## PROJECT ANATOMY CROSSWAYS BUSINESS PARK, DARTFORD KENT

## ISC Responsibilities

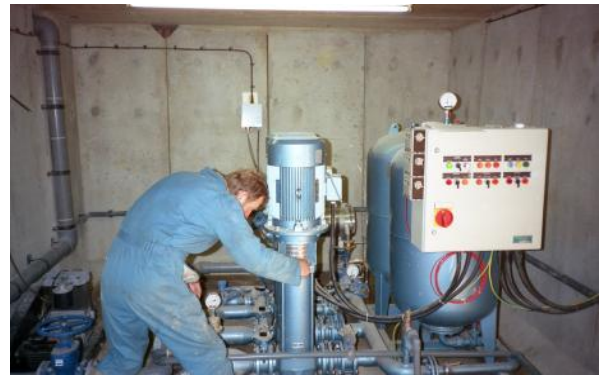
The pump station was built into the bank of the lake with the suction pipe emerging from it under water. It is called "The Boathouse" and is further disguised by having a viewing platform on top of it. The power supply to the pump station also feeds power to the signature "Geneva" style fountain in the lake and the landscape lighting.

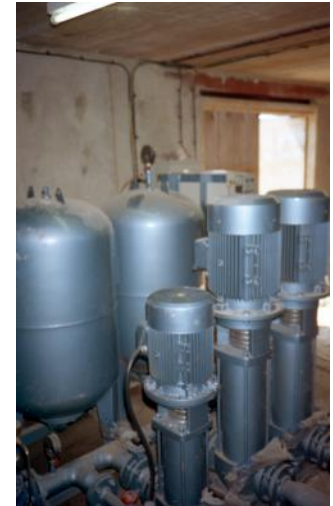
A four channel decoder type irrigation control panel was installed in the pump hose, backed up later by a second unit in a cabinet outside the Campanile Hotel.

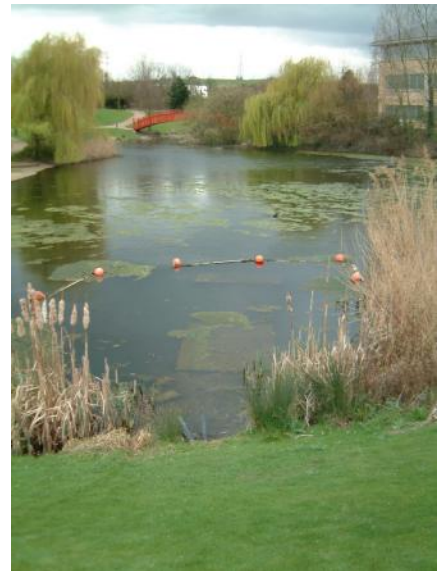
It was therefore decided that the pumps would be deep well type submersible units mounted in a vertical wet well built into the bank. There would be sufficient headroom above a false floor set at top water level for the new filtration system, discharge manifolds, filter drive manifolds, etc., to be installed leaving only a flush steel access cover visible at ground level. The wet well was connected to the lake by a 900 mm. diameter pipe running out under water which terminated in a mounting for a pair of very large rotary self-cleaning suction filters. The pump discharged into the system through a 100 micron automatic vacuum cleaning filter.
