## Case Study: Timberwise Framed by Client !

Beneath a large country manor house in Somerset stood a damp, dark and dingy stone barrelled vault.

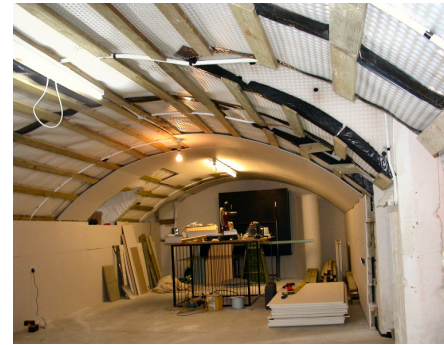
Basement Waterproofing Works in progress

The floor, walls and the ceiling of the vault were lined with a cavity drainage membrane and WaterGuard™ perimeter drainage was introduced around the perimeter of the existing concrete floor, discharging to an existing floor drain in the adjoining wine store.

The floor area was then over laid with 22mm moisture resistant chipboard and studding formed all round, walls plaster boarded and rough skimmed.

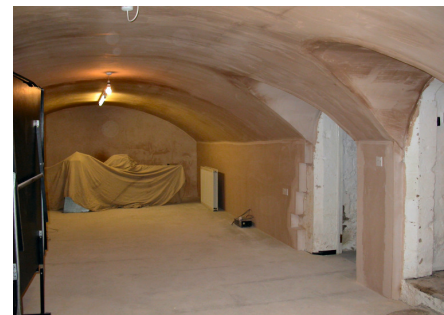
Completed Basement Waterproofing works awaiting decoration

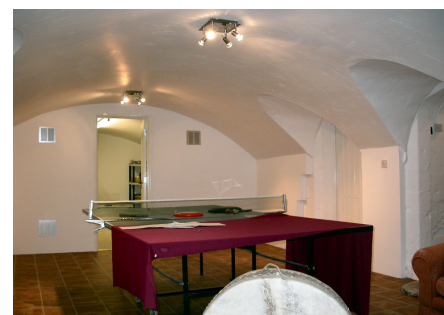
View from playroom into workshop

Having completed the works the client then decided to split the area into two and a central timber framed wall was introduced to form two distinct areas in the basement. With the improved lighting and the introduction of heating the client, who is a keen 'picture framer', now has a clean, dry and warm workshop whilst his children have a bright and spacious play room.
