WaterGuard™

Within this 'technical' information sheet we will explain how we use Basement Systems™ products to deal with failed tanking systems, and how we incorporate them within newbuild and existing building waterproofing systems.

Case Study

ATE, Oldham, Lancashire

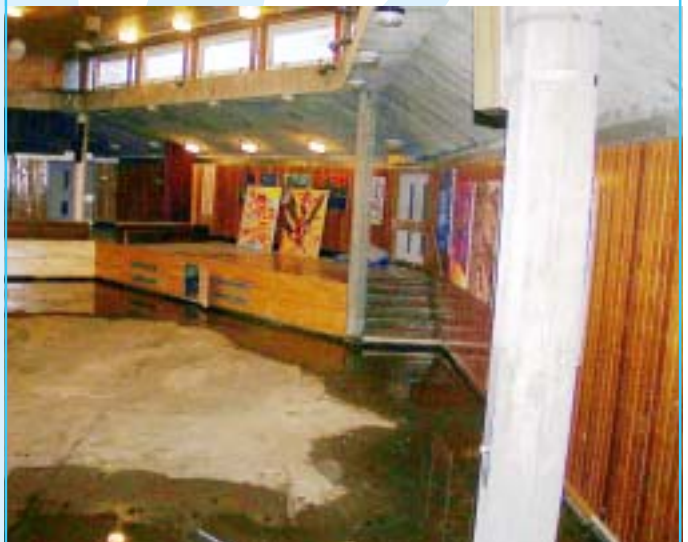
Type B, 'Integrally Waterproof' concrete, in the Assembly Hall of Acland Burghley School in Tufnell Park, London, failed and intermittently flooded. A typical problem, easily corrected by Trace Basement Systems™.

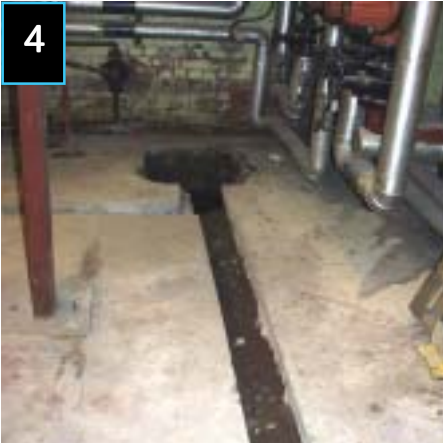
Mid-floor chases are cut out, ready for TrenchDrain™ (ACO), and a hole excavated for one of the sump locations.

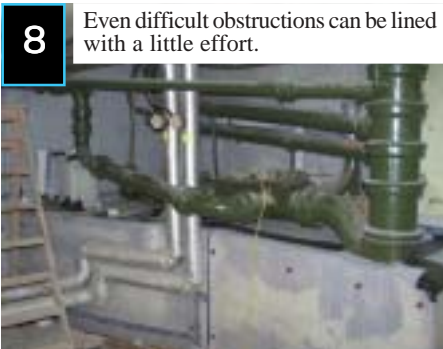
8 Even difficult obstructions can be lined with a little effort.

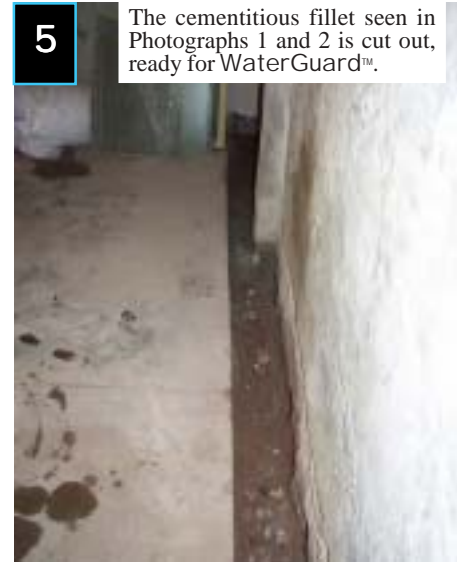
5 The cementitious fillet seen in Photographs 1 and 2 is cut out, ready for WaterGuard™.

Photographs 1, 2 and 3 were taken during initial inspection, with 1 and 2 showing how hydraulic cementitious tanking was added and added at wall and floor joints to try to prevent escape of water.

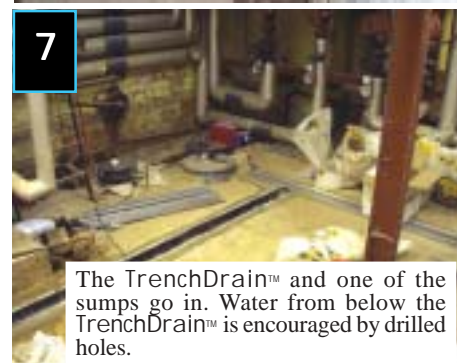
7 The TrenchDrain™ and one of the sumps go in. Water from below the TrenchDrain™ is encouraged by drilled holes.

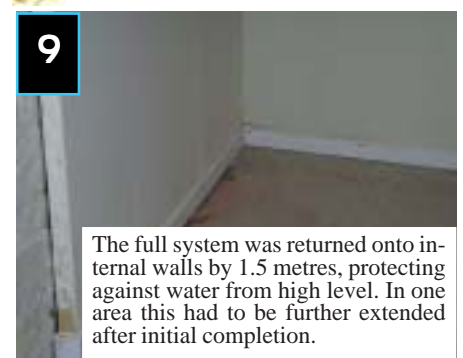
9 The full system was returned onto internal walls by 1.5 metres, protecting against water from high level. In one area this had to be further extended after initial completion.

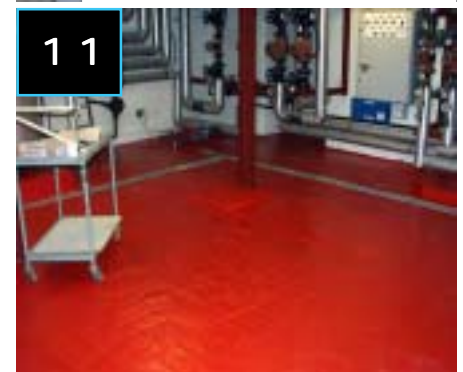
11

Ground water pressure had caused the added cementitious tanking screed to heave and crack. It was agreed that a periphery system of WaterGuard™ and two UltraSumps™ would be installed in sealed chambers, but because there was no evidence to indicate that water was escaping through the walls, they were excluded from the work on the premise that once WaterGuard™ relieved the pressure, penetration through the walls was even less likely.

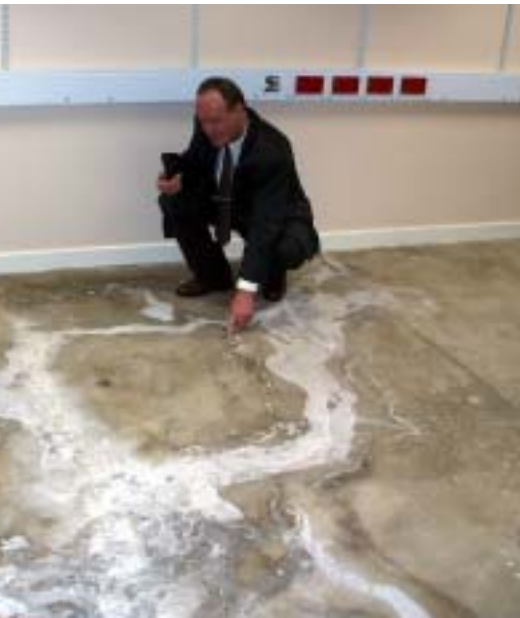
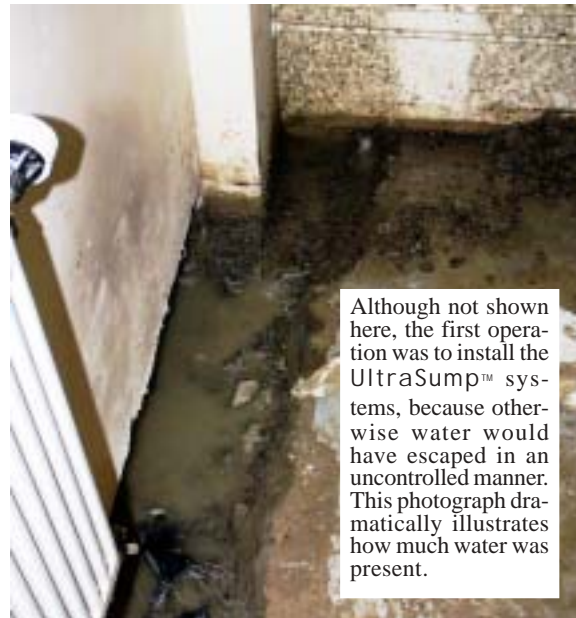
Although not shown here, the first operation was to install the UltraSump™ systems, because otherwise water would have escaped in an uncontrolled manner. This photograph dramatically illustrates how much water was present.

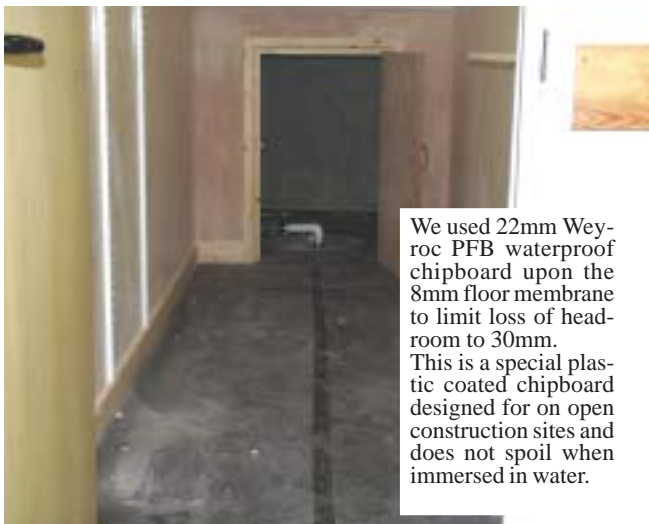
We used 22mm Wey-roc PFB waterproof chipboard upon the 8mm floor membrane to limit loss of head-room to 30mm. This is a special plastic coated chipboard designed for on open construction sites and does not spoil when immersed in water.

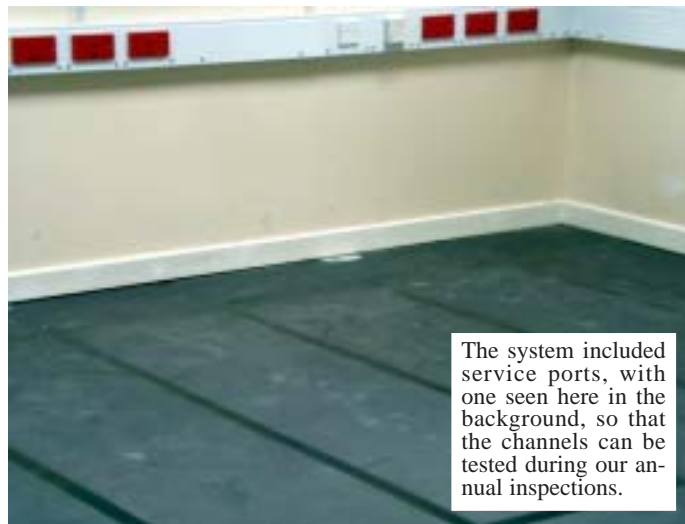
The system included service ports, with one seen here in the background, so that the channels can be tested during our annual inspections.

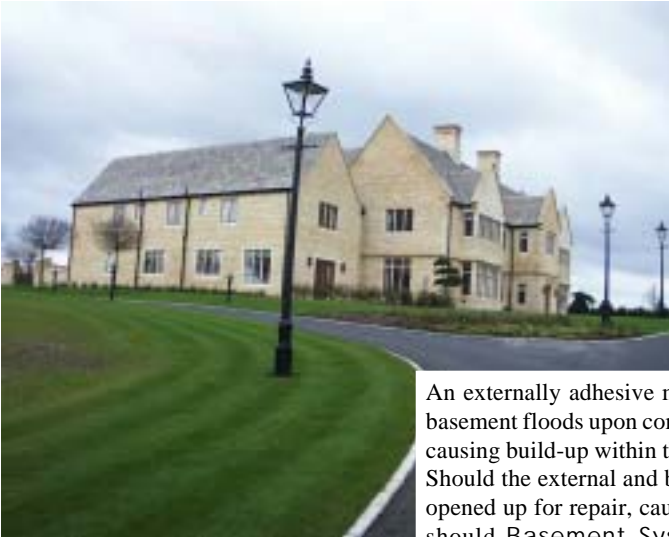
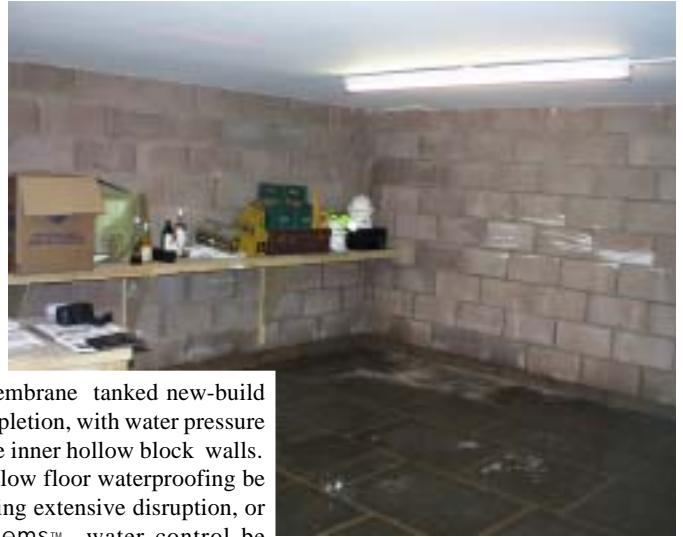
An externally adhesive membrane tanked new-build basement floods upon completion, with water pressure causing build-up within the inner hollow block walls. Should the external and below floor waterproofing be opened up for repair, causing extensive disruption, or should Basement Systems™ water control be considered?

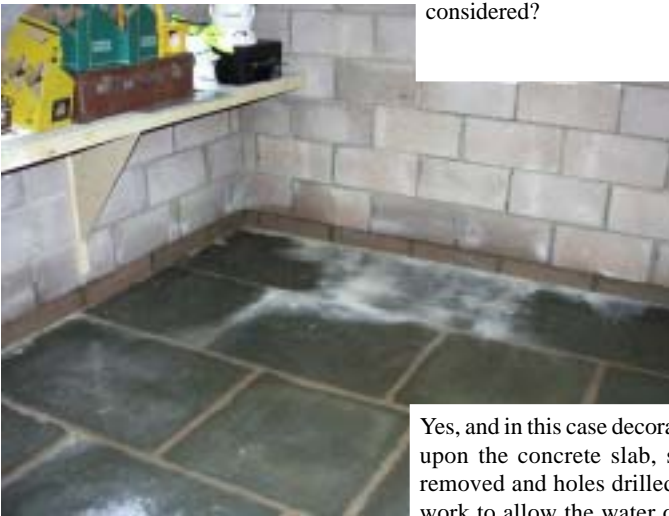
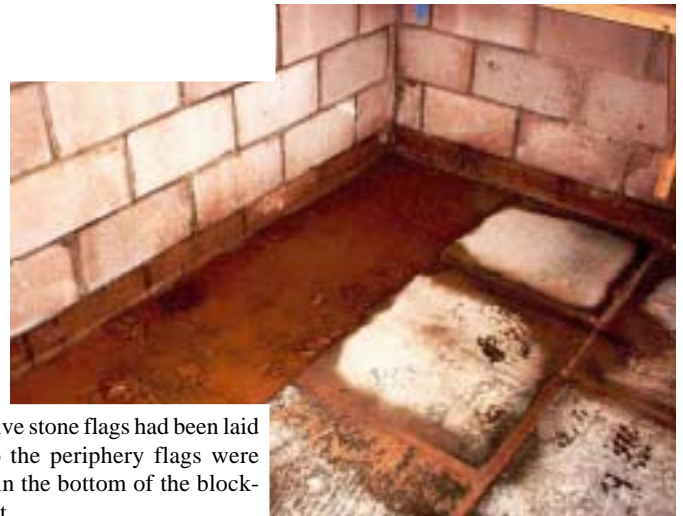
Yes, and in this case decorative stone flags had been laid upon the concrete slab, so the periphery flags were removed and holes drilled in the bottom of the block-work to allow the water out. See it standing where the flags were removed? It couldn't wait to get out once the build-up of ground water was released.

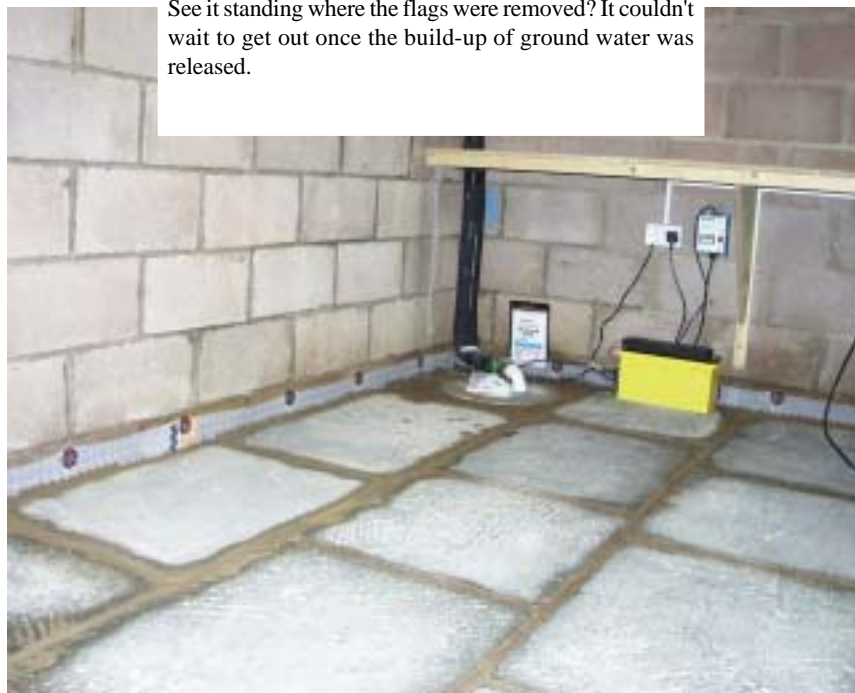
A skirt of cavity drainage membrane was added to compensate for the stone flags bridging the WaterGuard™ channels, allowing the basement to be used again. In waterproofing terms, WaterGuard™ sub-floor drain drainage channels are akin to reinventing the wheel.

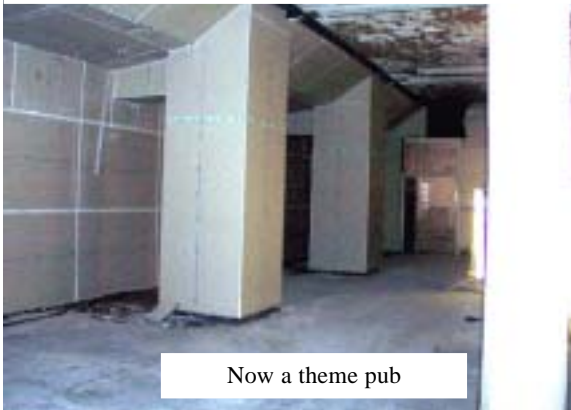
Showing how below pavement soffits can be lined and made dry, with water drained down sloping soffits and walls.

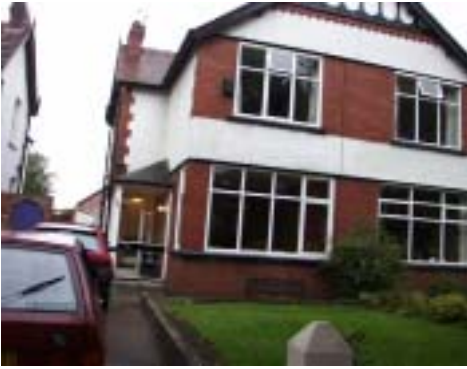
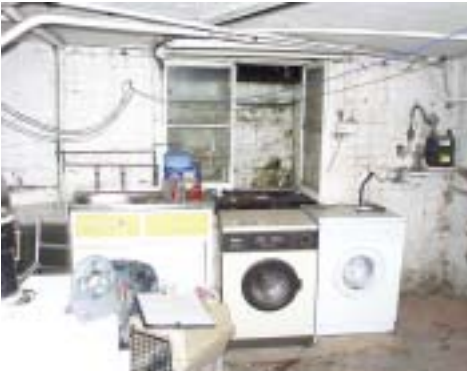
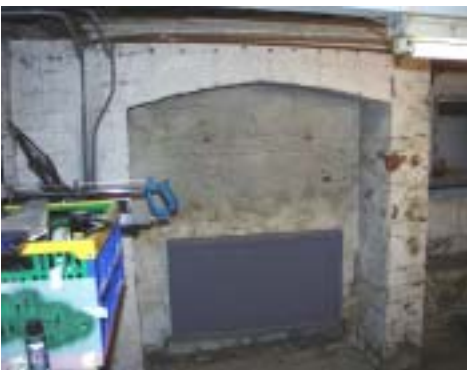
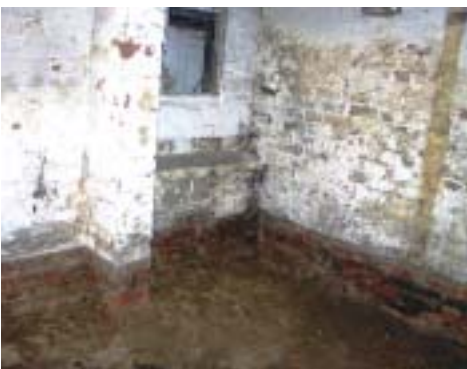
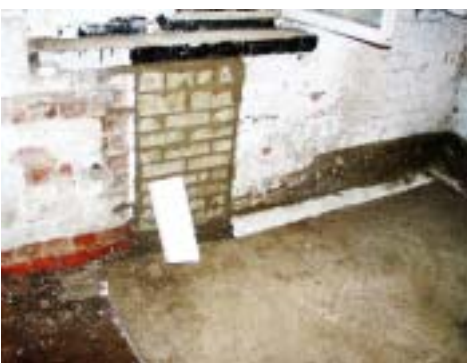
A typical dwelling house in a leafy suburb. It's basement has gradually become damp over the years, and at times of heavy rainfall, suffered from penetrating water, leaving usage limited.

The client wished to form a children's playroom and a study. Headroom was limited, so we excavated downwards, formed a concrete oversite, incorporating temporary polystyrene around the periphery. This was taken out after setting to allow Basement Systems WaterGuard™ drainage channels to be installed, linked to a Basement Systems SuperSump™.

Cavity drainage membrane was applied to the walls, taken down the back of the channels to cause penetrating water to be harmlessly diverted into the basement water control system. All walls were fully lined in the membrane to equalize the surfaces and to protect against ordinary rising dampness and salt contamination, all via special fixing plugs sealed back to the membrane where breaching.

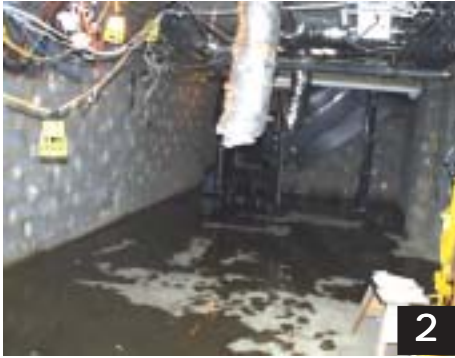
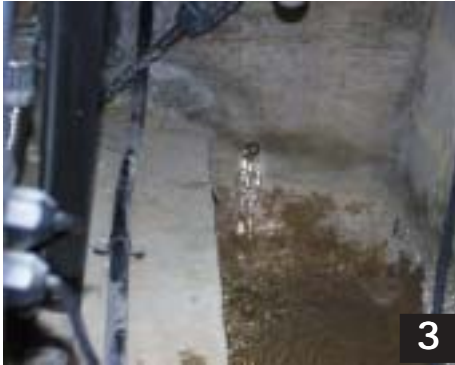
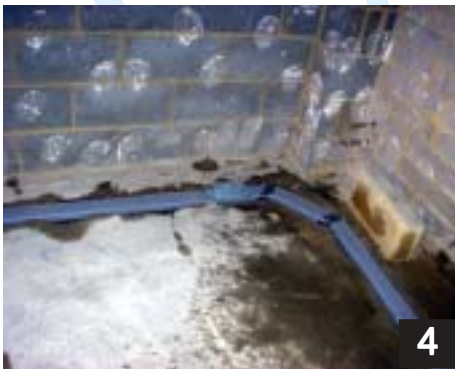
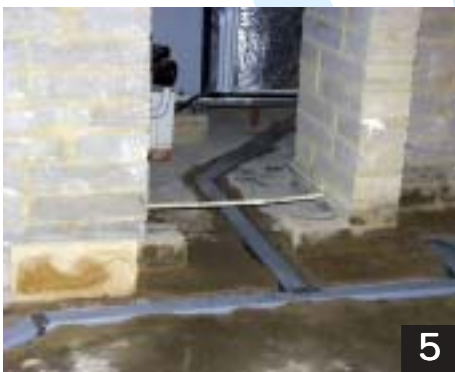
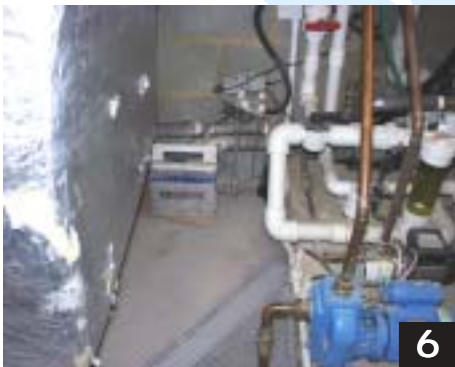
The basement contained a cinema and plant room off, the latter including services for a swimming pool, with plant both on the floor proper and upon concrete plinths. The original method of tanking involved sandwiched asphalt. However, water had penetrated at the basement wall and floor joints during construction, and after completion, with remedial measures at those times including adding of additional asphalt floor screeds and supporting concrete screeds. Attempts were then made externally, as seen in Photograph 1, to alleviate water pressure from outside, along with seeking the impossible by using hydraulic tanking internally at suspect wall and floor joint areas, only to find the water escaping elsewhere. Phil Hewitt Associates (01494 766655), the leading independent experts on waterproofing (Phil was the Expert Witness in the Outwing v Weatherald case which has changed the waterproofing liabilities of designers for evermore), were called in to advise. A remedial specification was drawn up and Trace Basement Systems were asked to inspect and quote. Liaising with Phil Hewitt and the instructing parties, a final specification was agreed, this taking into account our own recommendations based on our widening experience of dealing with flooded basements. By the time we were called to site, the cinema fittings, wall and floor finishes had been stripped out, with Photograph 2, showing what we saw, with water standing upon the floor, being advised that it intermittently worsened during and after heavy rain. Photograph 3 shows where we drilled the first hole in the plant room in the added hydraulic cementitious tanking, relieving the ground water pressure. It spouted out for over half an hour!. Basement Systems WaterGuard™ sub-floor drainage channels were laid within the floors, fully around the footprint of the cinema, kept away from the wall and floor joints to avoid undermining the block walls constructed off the screeds, as seen in Photograph 4, but because of the concrete plinths in the plant room, we fitted one central channel at floor proper level, and to avoid total disturbance of the plant, dressed 8mm stud cavity drainage membrane over the floor, up the plinths and up the walls only high enough to cover the vulnerable wall and floor joints. Photograph 6 shows the floor membrane over the channel in the plant room, which was then screeded, with water pressure relieved, controlled and the surfaces only sufficiently covered to ensure that it no longer escapes. The criteria in the cinema section called for a totally controlled environment, so the floor was fully covered in 3mm profile cavity drainage membrane, linked to 8mm stud cavity drainage membrane on the walls, with treated 50mm by 25mm timber battens, left ready for plasterboards. We covered the floor membrane with plastic covered Weyroc PFB chipboard (Photograph 7), with this combination leaving the client with thermally equalized finished surfaces, which can be fixed into without breaching the system. The environment will be economical to heat and totally protected against ground water by the products and methods already mentioned, along with the battery backup Basement Systems UltraSump™ seen in Photograph 8, which is the result of 14 years development, with more than 140,000 in the ground in the USA, Canada and the U.K.

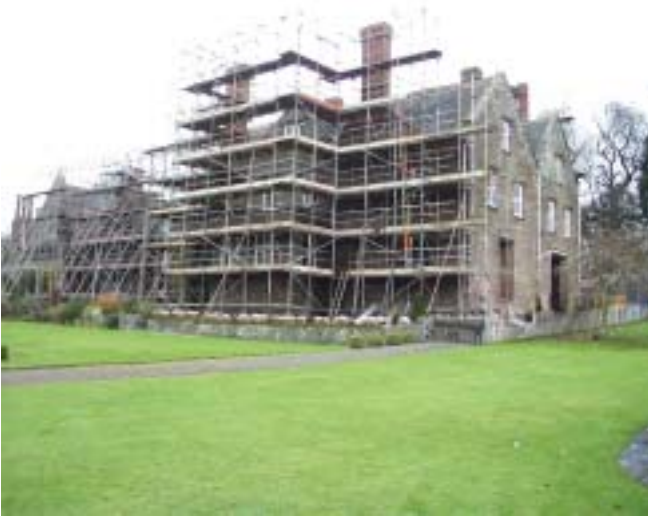
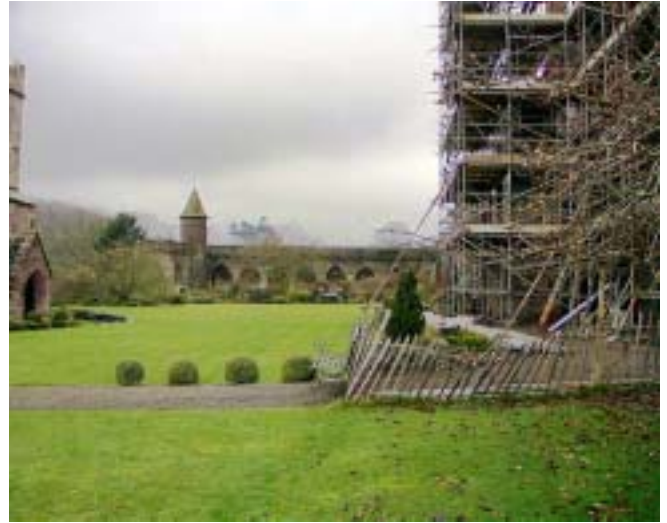
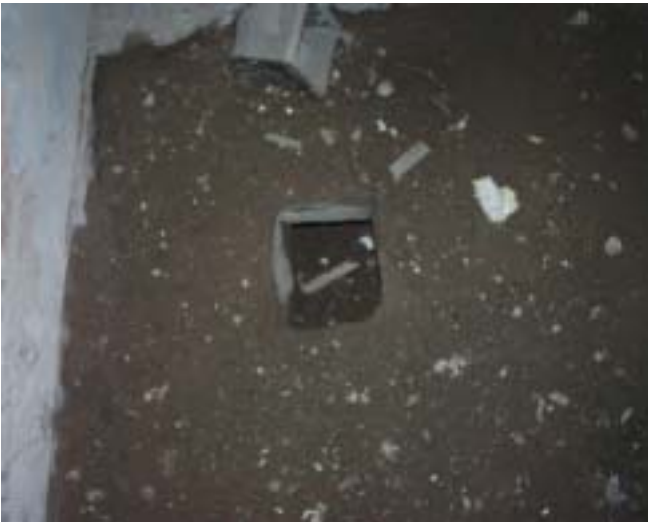
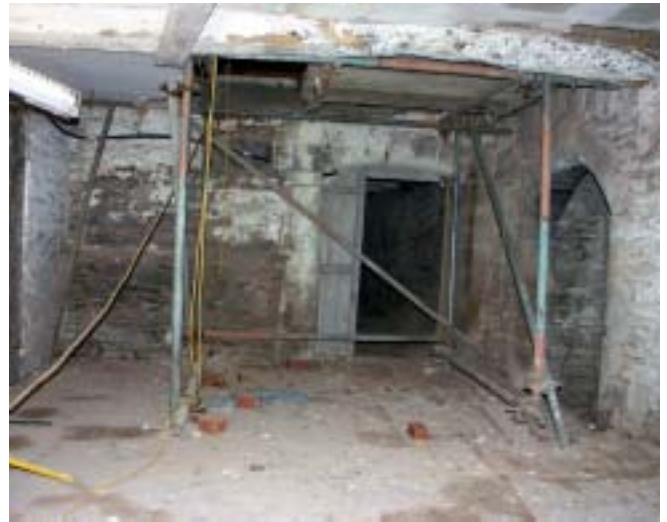
The property shown dates back 900 years, and although greatly altered and extended over the centuries, started out as Knights Templar Chapter House.

It includes basements of various ages, with the arch construction shown dating from the original time of construction, so is listed.

In 2002 we are to install a new **basement water control** system and drained protection waterproofing using cavity drainage membranes. The listed arch and adjacent wall will be left exposed, with local ground water pressure relieved with WaterGuard™ to replace the 900 year old channels. Cavity drainage membranes are particularly sympathetic to listed building because unlike direct applied tanking systems, the system is reversible and can be removed if required. A new bay was built off the arch position at ground floor, so we lined the arch in membrane before foundations were formed for the bay, preventing new concrete coming into contact with it..

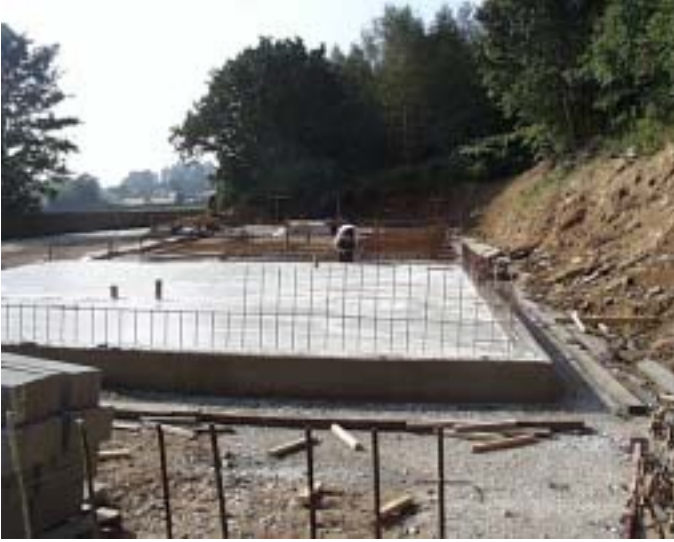
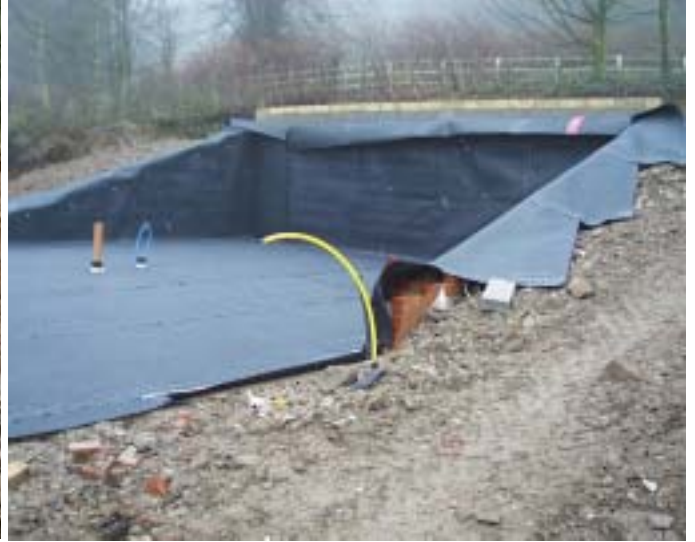
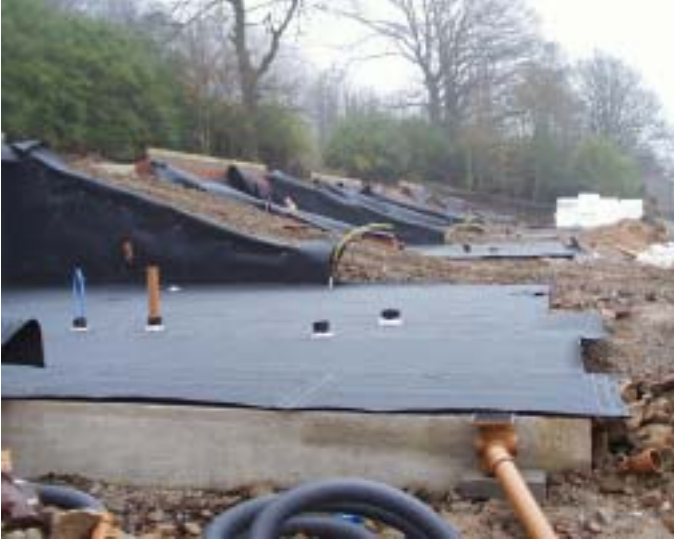
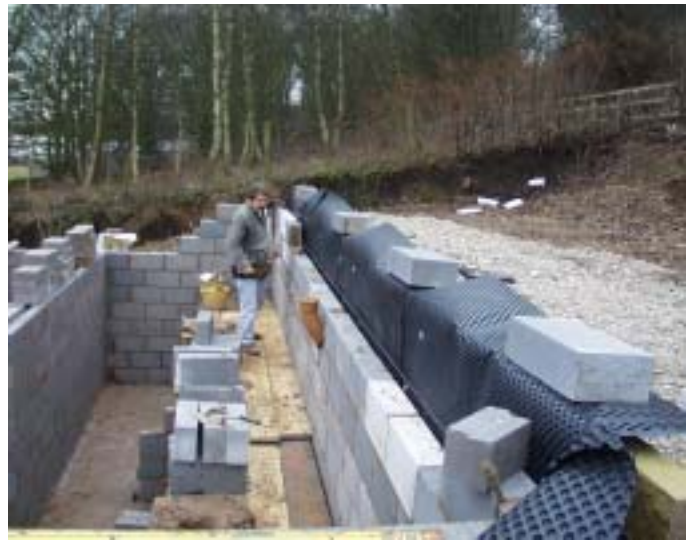
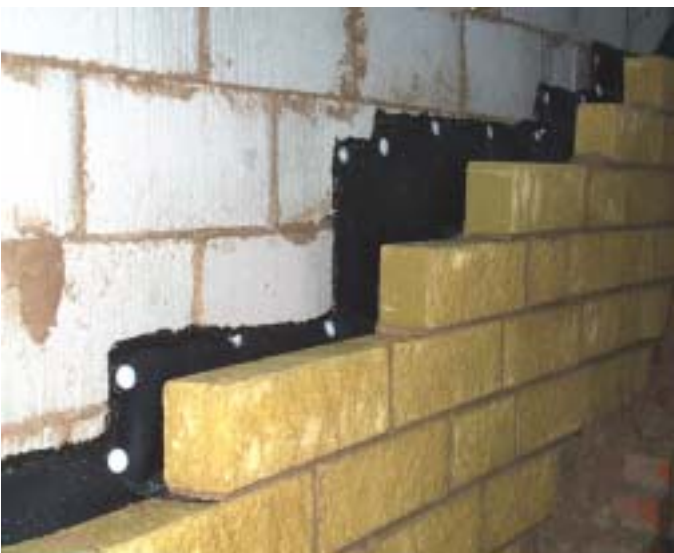
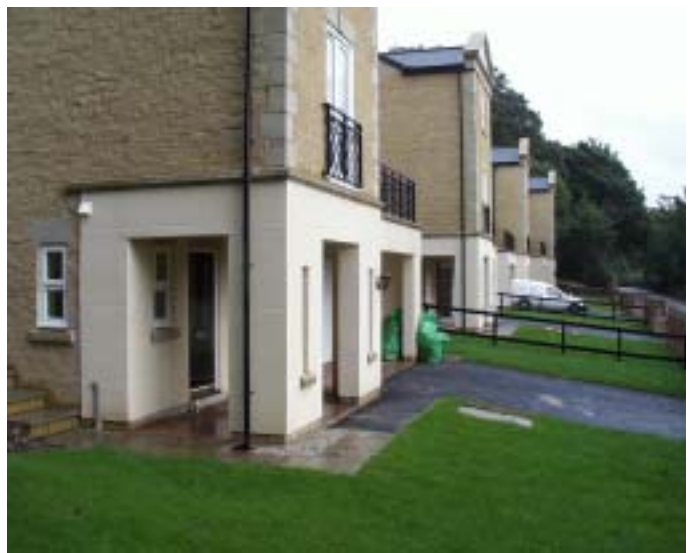
Newbuild Basement Into Sloping Hillside - Standen Park for Gleeson Homes - 1998

The simplest yet safest way to waterproof properties of this type. The only external measures included covering the top of the retaining wall sections with a cementitious slurry tank to limit water penetration into the steel reinforced concrete. The slab and reinforced concrete wall sections were constructed as normal, with the outer walls built up above proposed ground level, following which we cut chases into the slab (they could have been preformed when forming the slab), inserted Basement Systems WaterGuard™ sub-floor drainage channels, drained to low ground at the front (actually linked direct into the drains). The outer walls and slab were then lined in cavity drainage membrane, a screed laid and the inner block walls constructed, with sealed plugs fitted to accept wall ties. Any ground water that does penetrate through the retaining walls, will simply drain into the Basement Systems WaterGuard™ sub-floor drainage channels and from there evacuate to the drains. Is this not better than trying to form a perfect seal with a direct applied by 'tanking medium!'. We know it is not, because now that we have marketed our drainage technology since 1998, we currently undertake remedial works in both newbuild and existing 'tanked' basement on a constant basis!

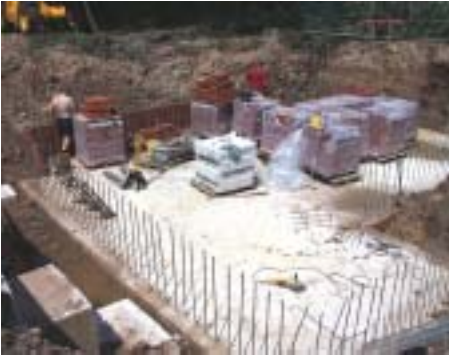
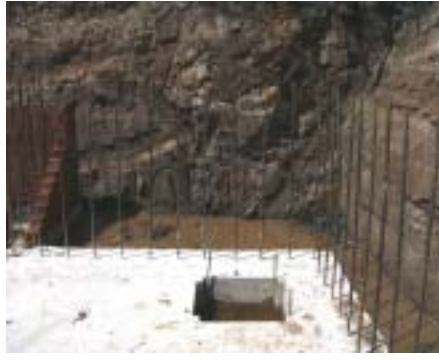
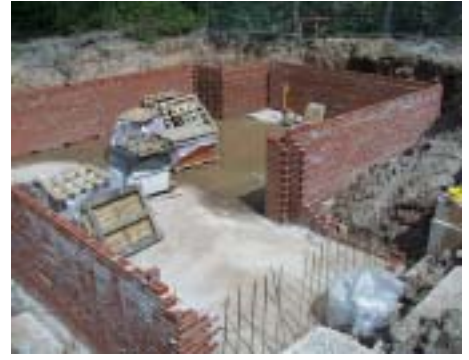
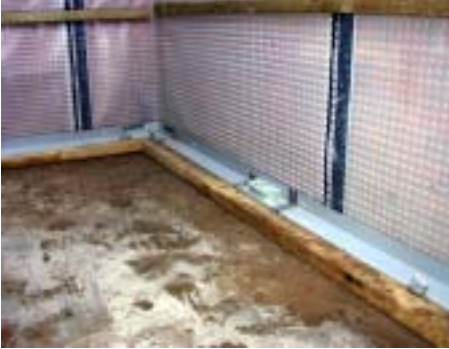
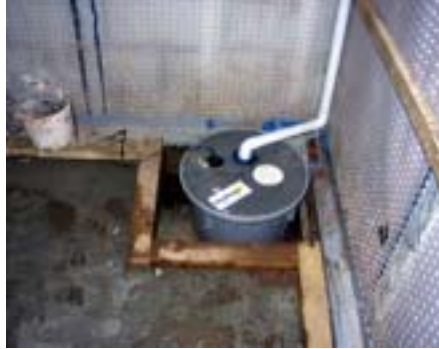
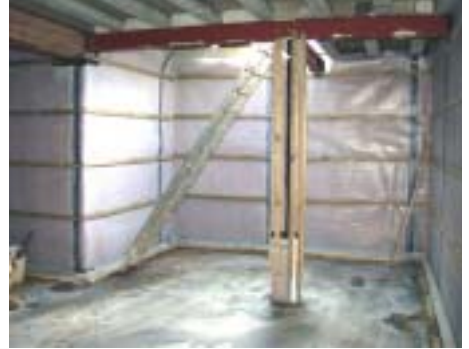
Newbuild Basement Fully Bridged By Ground - Private House, Bowden, Cheshire - 2001

Although a land drain was formed around the basement footprint, no other external waterproofing was undertaken, yet the system fully complies with BS8102:1990, Protection of Structures Against Water From The Ground. The Type C system met Grade 3 of that standard, with a sump chamber formed whilst laying the slab, and Basement Systems WaterGuard™ sub-floor drainage channels laid around the internal periphery, a lower screed laid inside the battens seen against the channels. The battens were removed, the space filled with stone, a cavity drainage dpm laid, linked to the same on the walls, with battens and plasterboard over. An upper screed was laid and the floor timbered over, although the timber could have been laid direct upon the floor membrane. The system included the light-well, with a meshed direct rendered membrane applied there to the retaining walls. Water is removed by a Basement Systems UltraSump™. Structural considerations in newbuild basements include whether the chases can be pre-formed in the slab, and whether to use a perforated sump to drain the soil, or a sealed sump to limit water collection to that entering from the WaterGuard™.
