CASE STUDY

Tarleton Bridge | Lancashire

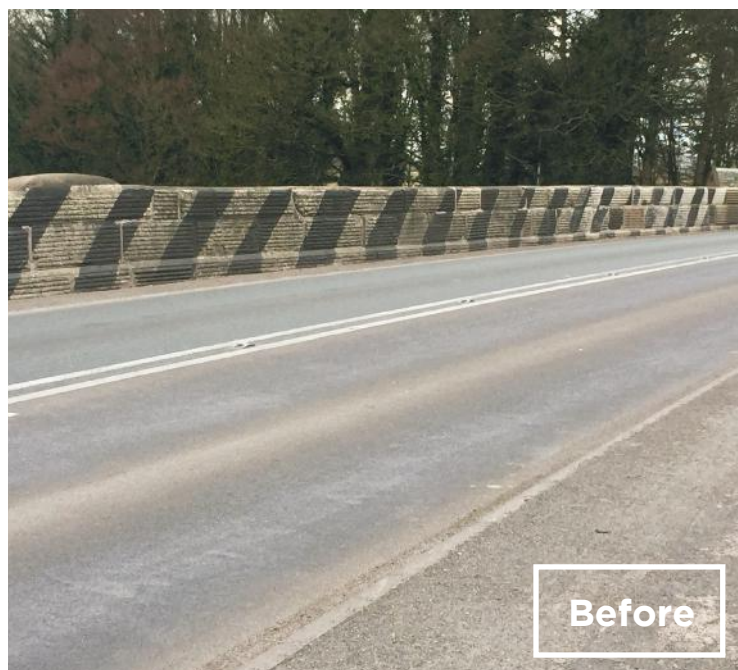
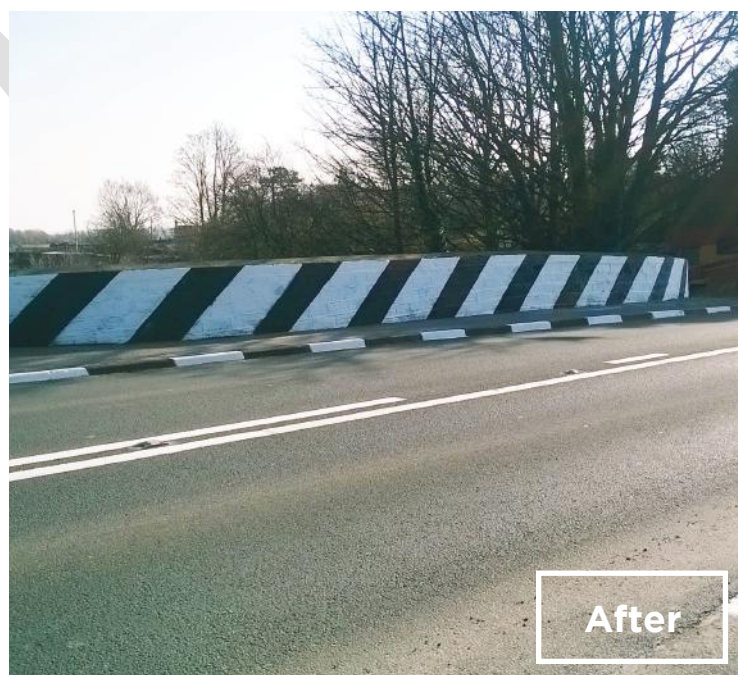
A heavily trafficked bridge in Lancashire had seen a rise in accidents, which was attributed to poor quality markings on the road and the bridge parapet itself.

The proposed solution was to re-mark all the road markings, re-apply the chevron stripes to the bridge parapet and replace the road stud inserts. Meon supplied products, including:- Spectrum UltraLine for the road markings, to provide maximum durability even under high traffic volumes; Spectrum ViaLine, used to provide bright, sharp contrasting chevrons on the parapets; glass beads, used with both Spectrum products to provide retro-reflectivity; new depressible stud inserts, further improving night-time safety.

The whole install was expertly carried out to a very high standard. Deployment of class-leading equipment such as the LineLazer 130HS airless spray machine facilitated a rapid and effective install, and the use of advanced materials from the Spectrum range will assure a long service life.

The finished result is crisp vibrant markings, which have been well-proven to improve road safety and reduce the incidence of accidents. The asset owners should be congratulated on their resourcefulness in making such a huge improvement!
