Case Study: The HSBC - Sheffield

HSBC, Sheffield

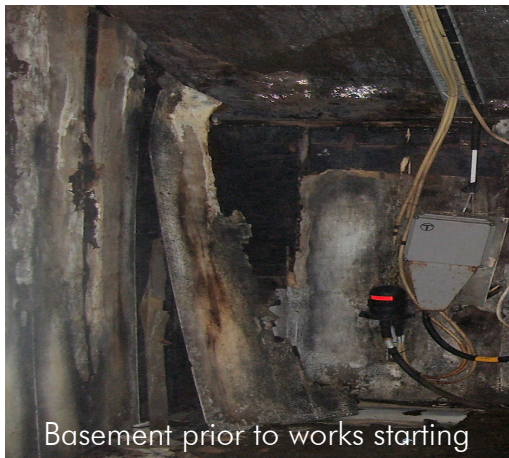
Basement prior to works starting

The problem was simple: the basement had no form of protective wall coverings making it an unsightly and unhygienic area which harbored damp, dirt and decay. To make matters worse live mains services were also housed in this damp area making for a potential hazard.

The solution that Timberwise decided upon was simple yet practical - a membrane barrier system was specified to the wall, ceiling and floor to prevent damp penetrating the basement space

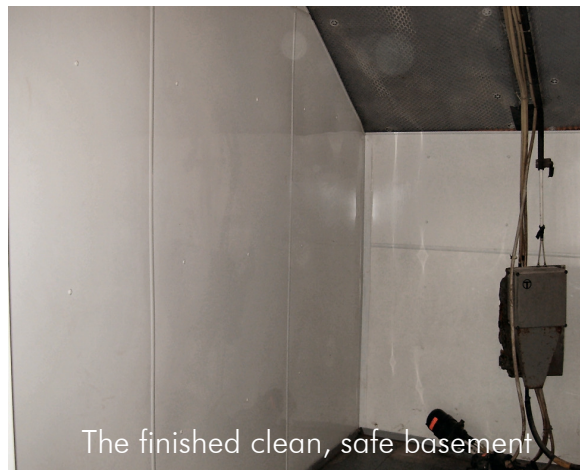
The finished clean, safe basement

The end result: A clean, dry basement area and a very satisfied client.

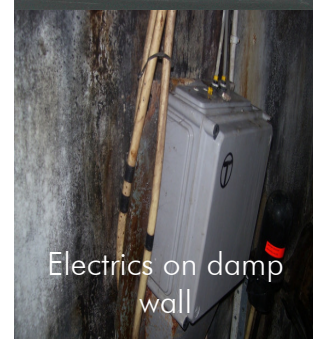
Electrics on damp wall

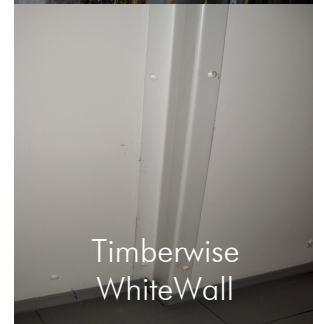
For the walls a heavy duty wall cladding system was used to prevent moisture ingress. The Timberwise WhiteWall system is durable and functional and also benefits from been completely washable making for a very clean basement area. The wall cladding also meets Hygiene Regulations and due to its smooth exterior can be disinfected with ease.

Timberwise WhiteWall

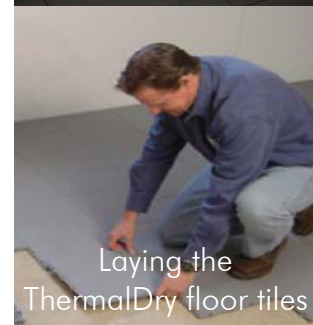
For the ceilings a cavity drainage membrane was employed and joined to the wall covering. On the floor ThermalDry Floor tiles were used. These floor tiles which simply click together, overcome the issue of condensation forming on the concrete floor. The tiles provide a very effective barrier against moisture vapour and capillary moisture allowing a 'decorative' flooring to be safely laid.

Laying the ThermalDry floor tiles

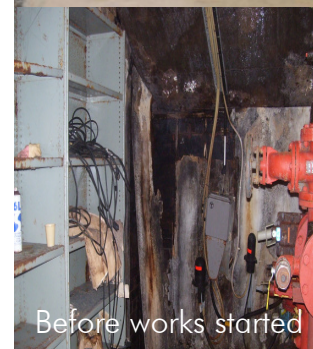
Before works started
