Health Estate

Tap upgrade wins praise all round

An ongoing upgrading of clinical handwashing facilities at its hospitals by NHS Lanarkshire is seeing the Scottish Health Board replace, in many cases, ageing basins and taps subject to Healthcare Environment Inspectorate (HEI) criticism, with standardised modules comprising a clinical basin, Horne Engineering's Optitherm thermostatic tap, and soap and towel dispensers, all mounted on a single integrated panel structure. As Horne's marketing manager, Hannah Berry, explains, one of the many benefits is that the Board's Estates Department no longer needs a large "arsenal" of spare parts in stock for different fittings.

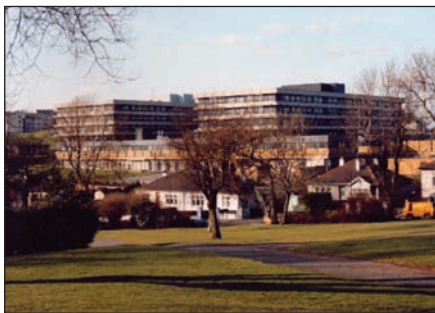
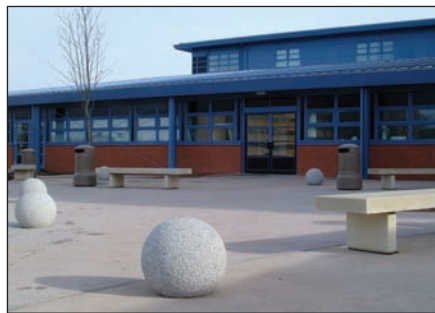
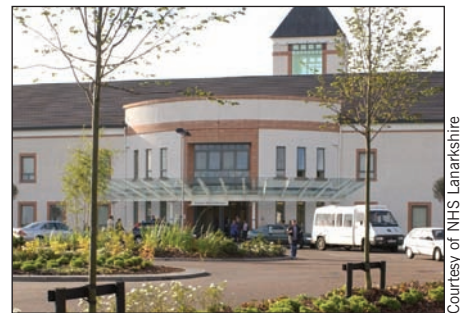
Optitherm taps are now in use, or being installed, not only at the Monklands Hospital (left), but also at the Hairmyres Hospital (centre) in East Kilbride, and at the Wishaw General Hospital (right).

The Optitherm tap, which comprises a thermostatic mixing valve (TMV), warm water tap, and a dedicated cold water tap combined into a single unit that offers significant benefits relating to installation, operation, and maintenance, was first trialled out at Monklands Hospital, a large district general hospital offering acute services and a 24-hour

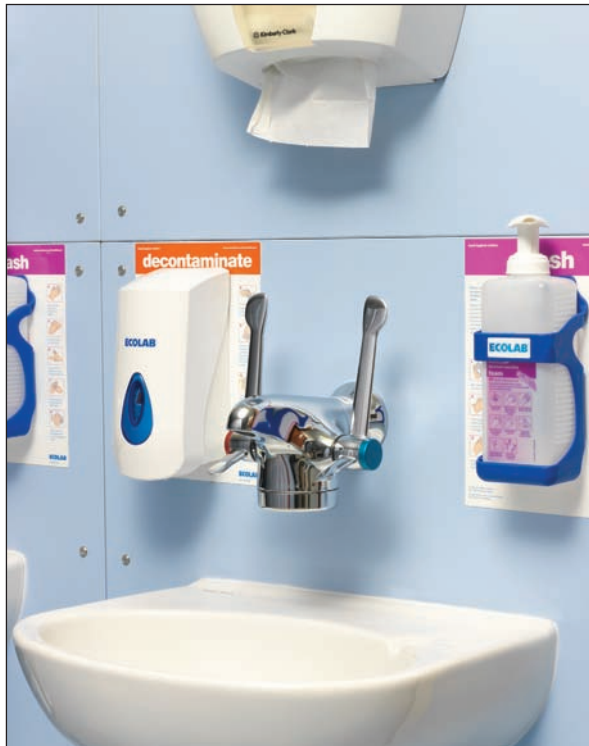
The Optitherm was considered very easy to clean due to its smooth and rounded shape, and “lack of nooks and crannies”, while access for maintenance is also straightforward, with no need to remove the wall panel.

From a cleaning and infection prevention perspective, the tap was considered very easy to clean due to its smooth and rounded shape, and "lack of nooks and crannies". The infection control team was initially concerned about the combined flow regulator and conditioner, and there was much debate as to whether it was an aerator or not. Once its function was properly explained – it regulates the flow to 6 litres/minute, and "conditions" the water column to ensure it falls in a uniform, unbroken manner into the basin with no splashing or forming of aerosols – this was accepted, and the Optitherm was selected for installation.

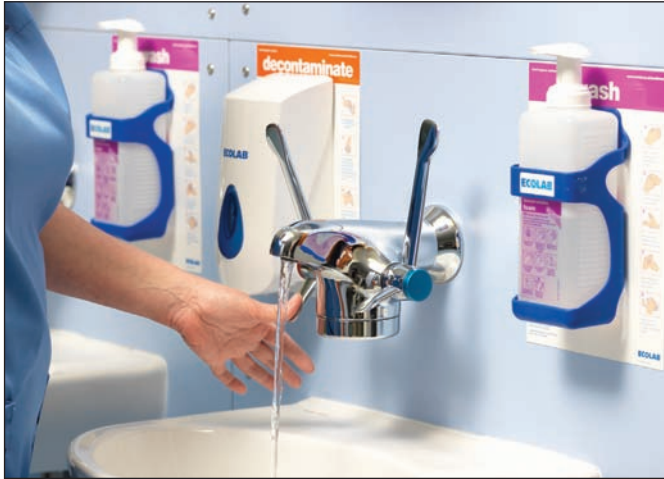
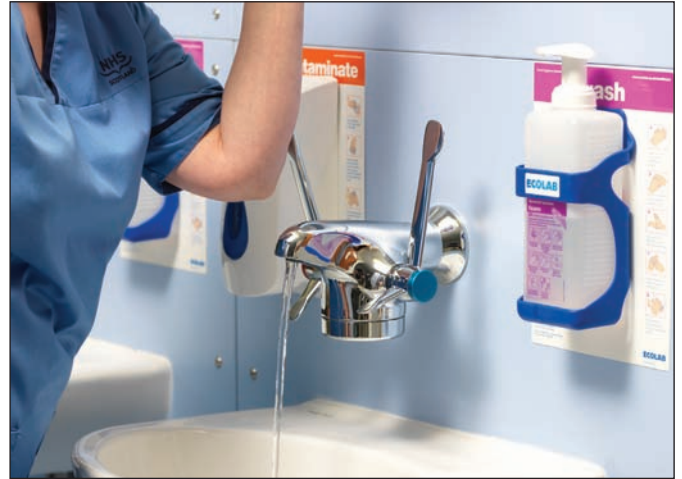
To aid hygienic handwash, the Optitherm's double lever operation allows the tap to be operated using the thumb, then turned off using the elbow or upper forearm, while the outer surface is continuous and smooth for easy cleaning.

The anti-vandal clutch mechanism on the levers was also considered a valuable feature, as it prevents the levers from snapping should excess force be applied to them. A person intent on breaking the lever may push it in either direction with force; initial resistance will suddenly cease as the lever moves around its axis by a “notch”. The vandal incorrectly assumes that the

lever mechanism is broken, but this is a deliberate feature, and there is no risk of the lever snapping. The lever position is corrected simply by ratcheting it back in the reverse direction, again with moderate force, until the resistance ceases.
